# Precision Home Inspections & Toxic Testing

**INSPECTION DESCRIPTION:** Home Inspection

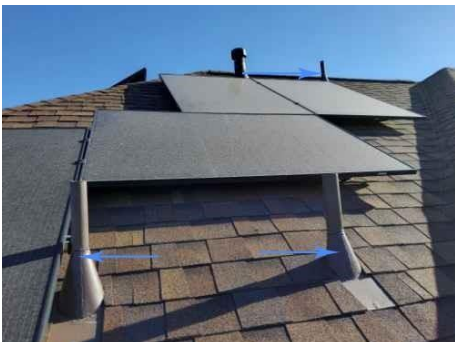
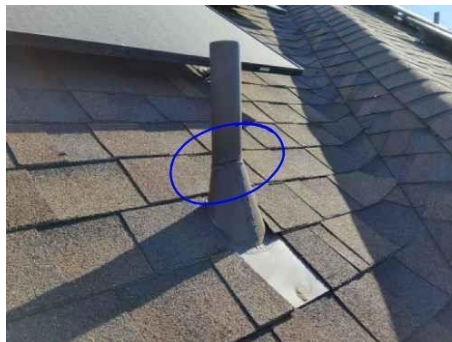
The sealant between the pipe and the boot is falling apart. This can allow water down into the attic and home area. Recommend adding more sealant.

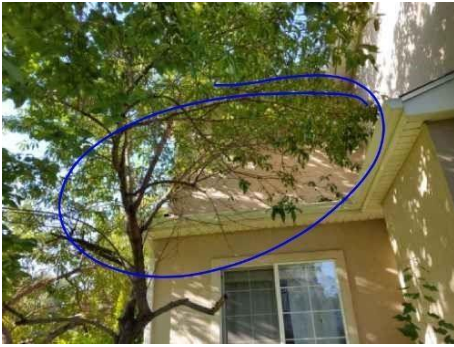
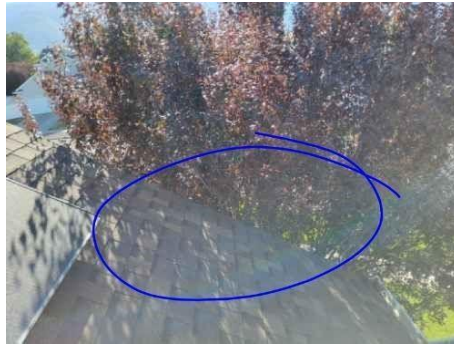
**VEGETATION** Fair

It is recommended that shrubs and overhanging trees have a minimum of 12" clearance to prevent damage to the house.

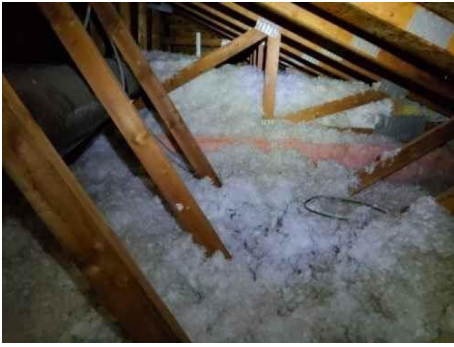
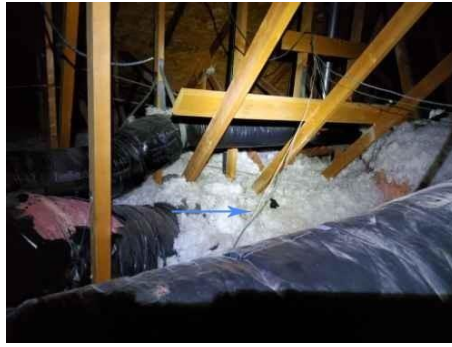
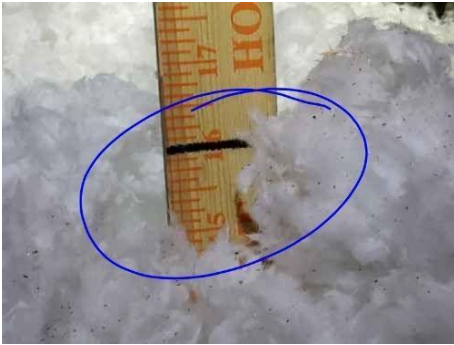
## **INSULATION** Fair

Attic insulation in colder climates like Utah should be around 14 to 16 inches deep. The insulation is about 16 inches deep.

There's a water stain in the insulation. It was not wet at the time of the inspection. It looks as though it would have come from an old turtle vent which has been replaced. Continue to monitor, if condition deteriorates contact a qualified contractor.

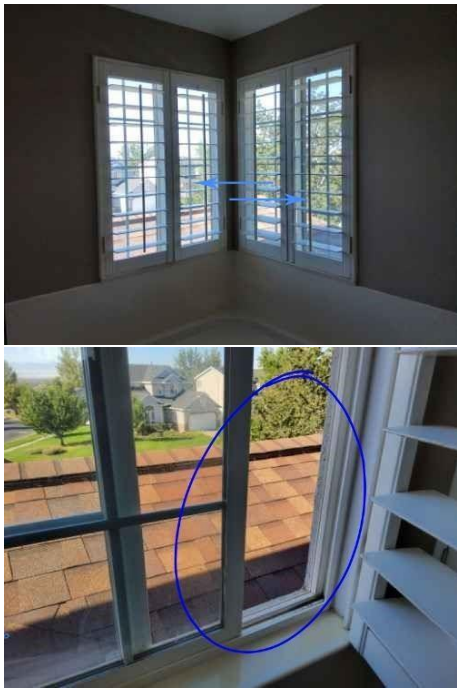
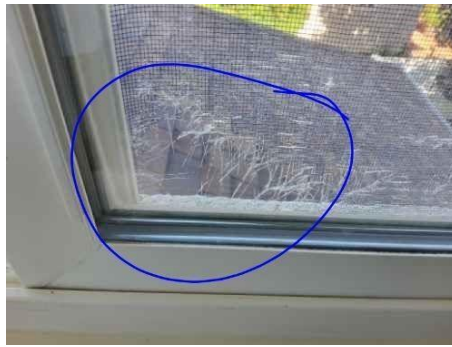
**WINDOWS** Fair

The west window screen is falling apart and the south window is missing the screen. Recommend repair/replacement by a qualify window contractor.

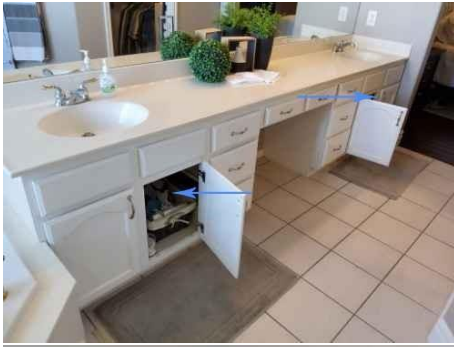
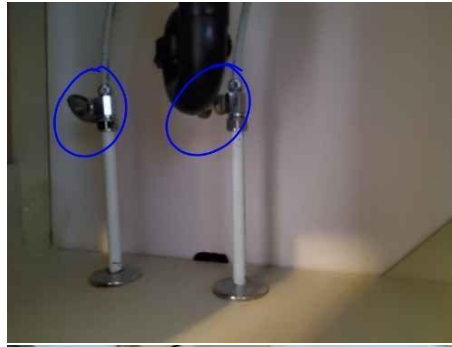
**SINKS** Fair

I am unable to turn some of the shut-off valves on the supply lines. They should turn very easily. I do not attempt to force them because they may break.

The north sink is starting to crack.

The stopper on the north sink does not function properly. It does not stop the water from going down the drain.

Recommend further evaluation from a qualified plumber or handyman.

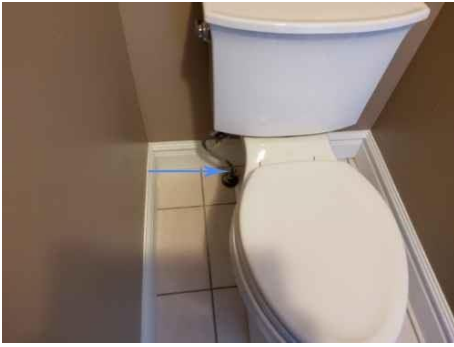
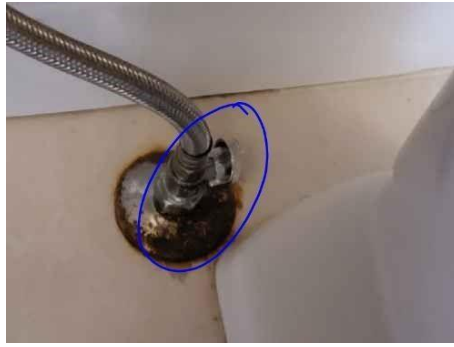
## TOILET Fair

I am unable to turn the shut-off valve on the supply lines.  
They should turn very easily. I do not attempt to force them because they may break.  
Recommend further evaluation from a qualified plumber or handyman.

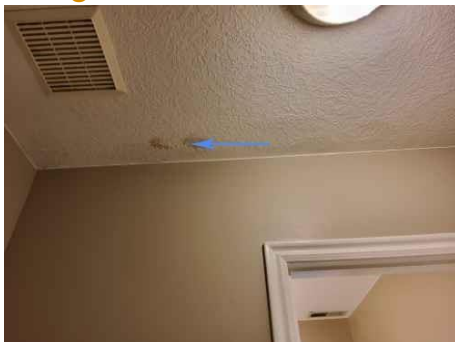
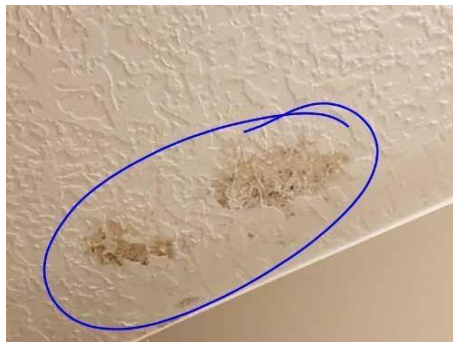
The ceiling in the room above the toilet has the appearance of mold growth. Recommend treating with mold control.

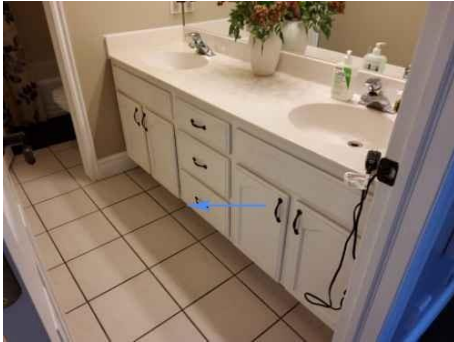
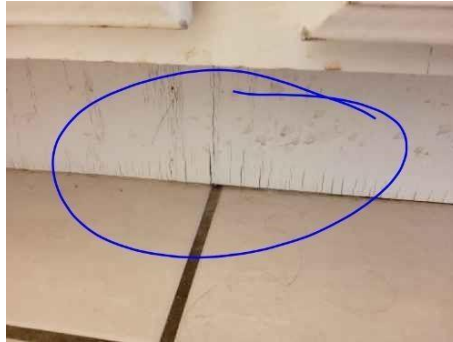
The base of the cabinets have signs of water damage. It was not wet at the time of the inspection. Continue to monitor, if condition deteriorates contact a qualified contractor.

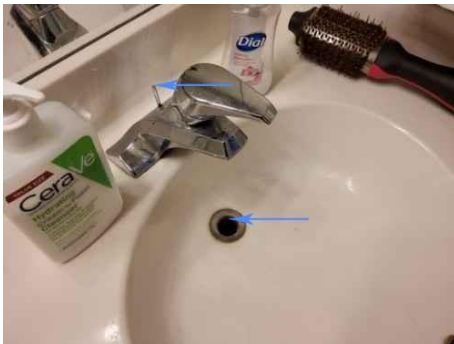
**SINKS** Fair

I am unable to turn the shut-off valve on the supply lines.  
They should turn very easily. I do not attempt to force them because they may break.

The stoppers do not function properly. They do not stop the water from going down the drain.

Recommend further evaluation from a qualified plumber or handyman.

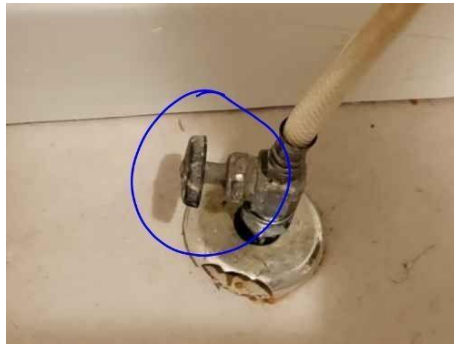
### TOILET Fair

I am unable to turn the shut-off valve on the supply lines.  
They should turn very easily. I do not attempt to force them because they may break.

Recommend further evaluation from a qualified plumber or handyman.

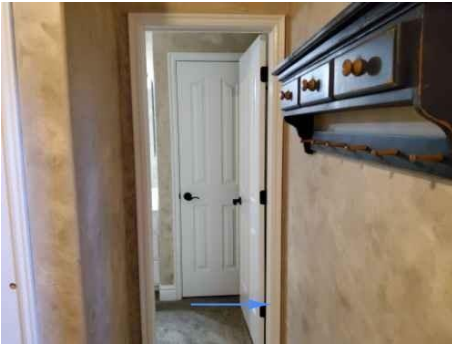
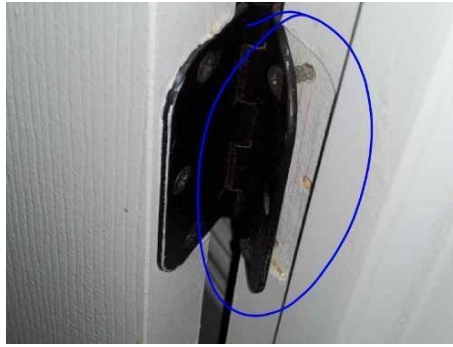
**DOORS** Fair

The bottom hinge is loose. Recommend repair/replacement by a homeowner or handyman.

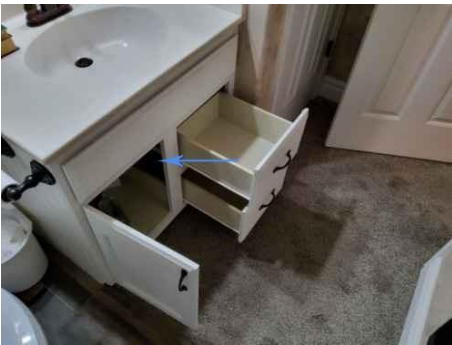
There are mouse droppings under the sink behind the drawers.  
Recommend further evaluation/repairs by a qualified pest contractor.

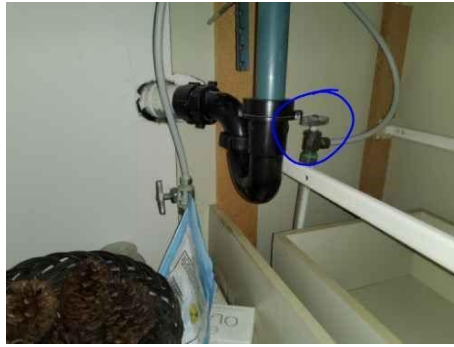
## **SINKS** Fair

I am unable to turn the shut-off valve on the supply lines.  
They should turn very easily. I do not attempt to force them because they may break.  
Recommend further evaluation from a qualified plumber or handyman.

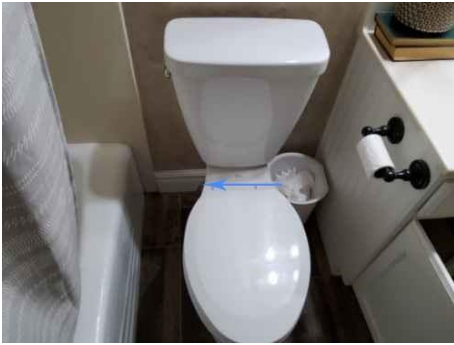
## TOILET Fair

I am unable to turn the shut-off valve on the supply lines. They should turn very easily. I do not attempt to force them because they may break.

The flapper inside the tank is not functioning properly which is allowing water to go inside the toilet bowl constantly and will cause the toilet to continually flush on its own.

Recommend further evaluation from a qualified plumber or handyman.

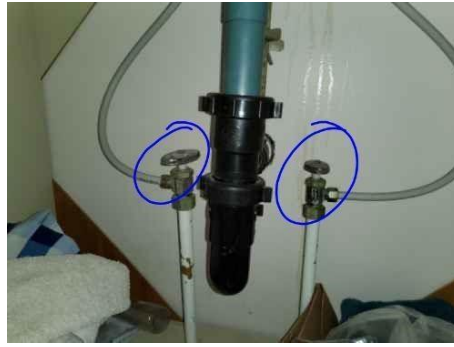
**SINKS** Fair

I am unable to turn the shut-off valve on the supply lines.  
They should turn very easily. I do not attempt to force them because they may break.  
Recommend further evaluation from a qualified plumber or handyman.

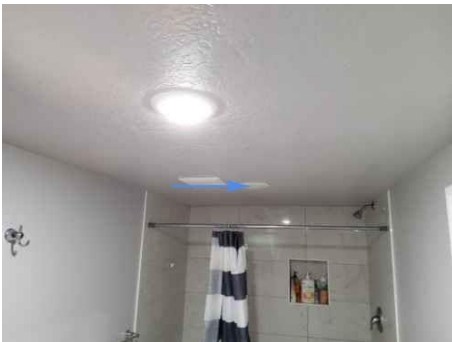
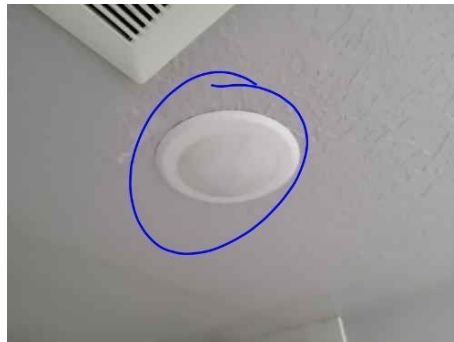
The light by the shower does not work. If it does not work after changing the bulb, recommend contacting a qualified electrician.

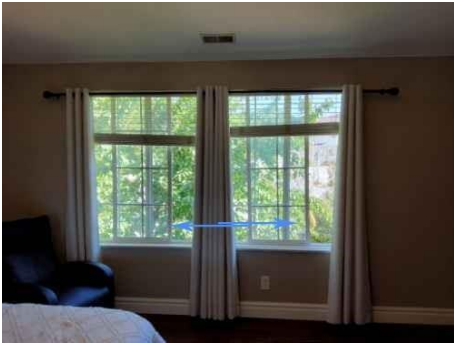
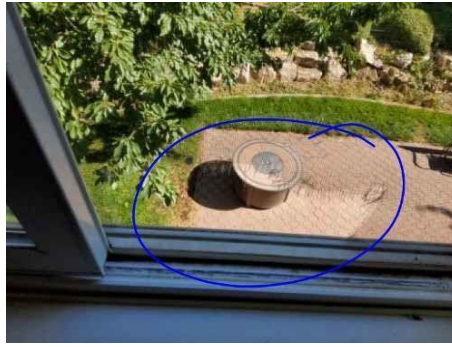
**WINDOWS** Fair

Both the window screens are falling apart. Recommend repair/replacement by a qualify window contractor.

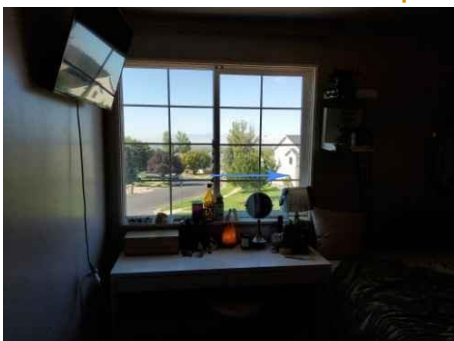
The window is missing the screen. Recommend repair / replacement by the homeowner or qualified window contractor.

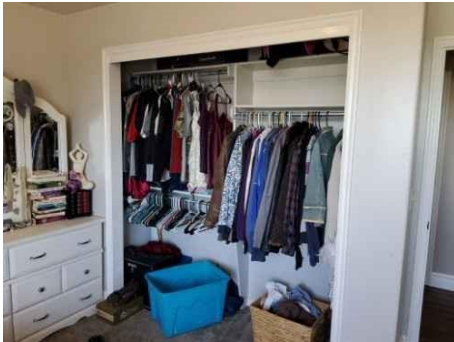
The doors are missing from the closet. Recommend repair / replacement by a homeowner or handyman.

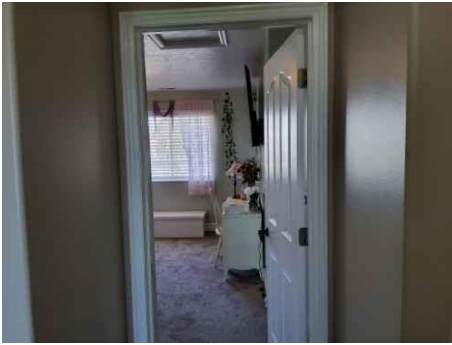
The hinges are loose. Recommend repair/replacement by a homeowner or handyman.

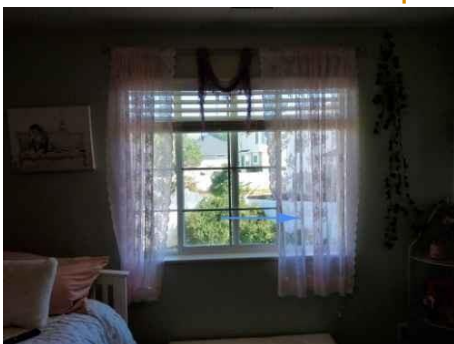
## **WINDOWS**      Fair

The window is missing the screen. Recommend repair / replacement by the homeowner or qualified window contractor.

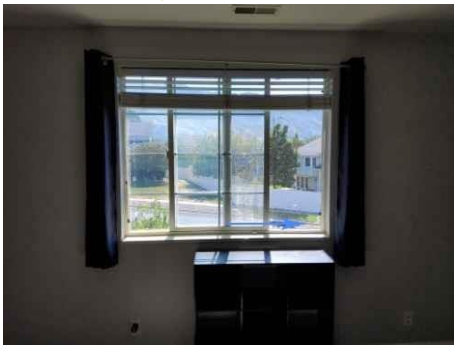
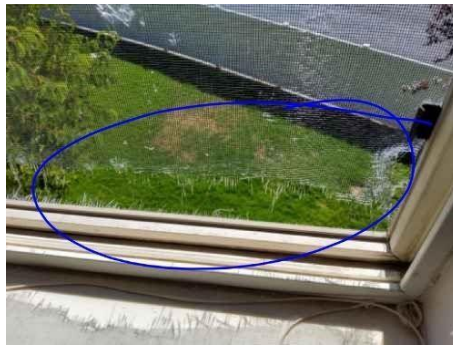
**WINDOWS** Fair

The window screen is falling apart. Recommend repair/replacement by a qualify window contractor.

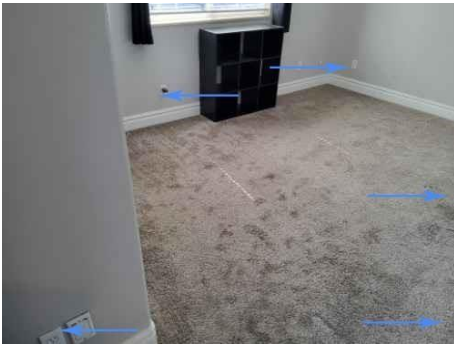
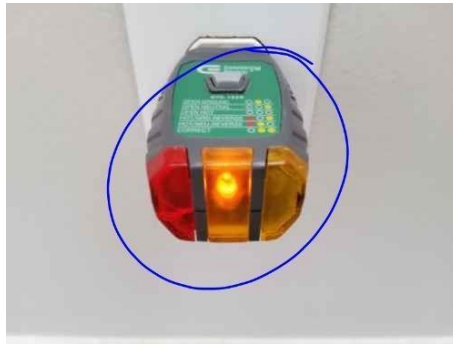
**OUTLETS** Poor

All the outlets indicate an open ground.

Recommend further evaluation from a qualified electrician.

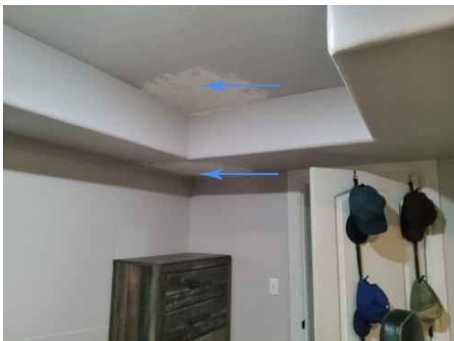
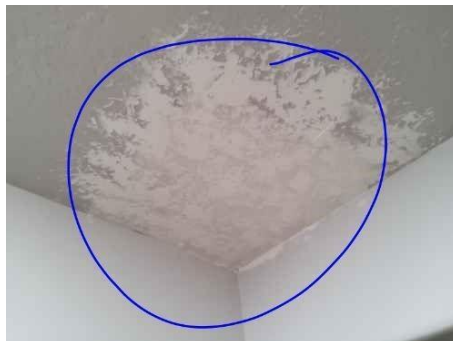
There are repairs in the ceiling by the door. It was not wet at the time of the inspection.

Recommend asking the current owner that cause of the ceiling repair.

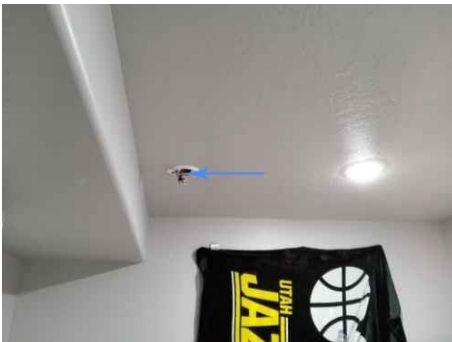
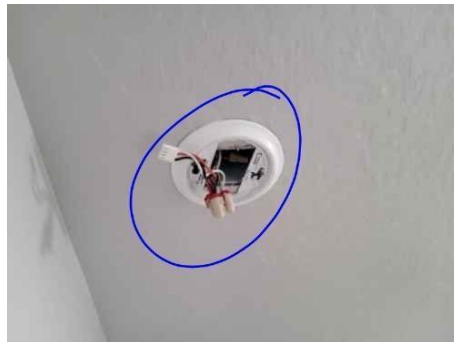
The smoke alarm is missing from this bedroom. Recommend replacing it.

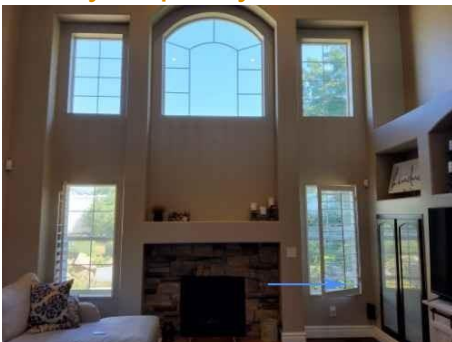
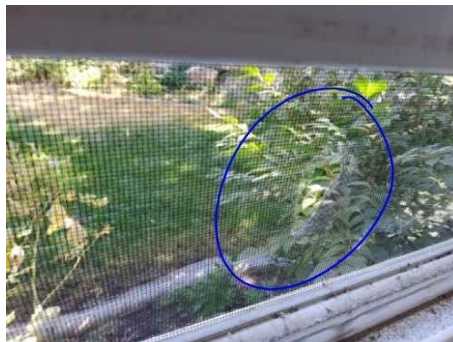
The east window screen is falling apart. Recommend repair/replacement by a qualify window contractor.

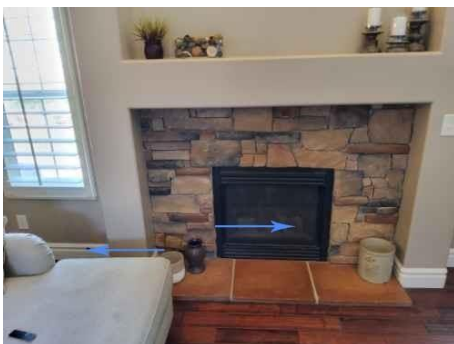
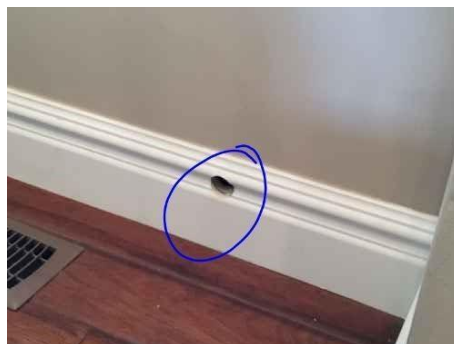
## FIREPLACE Poor

I was unable to get the fireplace to ignite. There is a key slot in the wall to the left of the fireplace to turn the gas on. It was turned on but I was still unable to ignite the fireplace.

Recommend further evaluation/repairs by a qualified fireplace contractor or handyman.

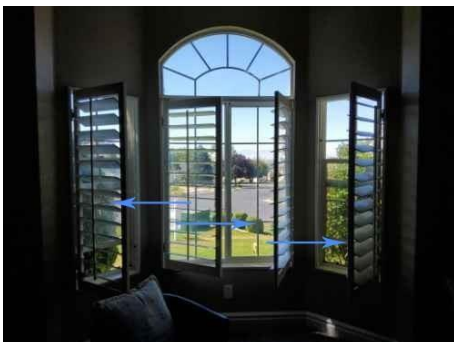
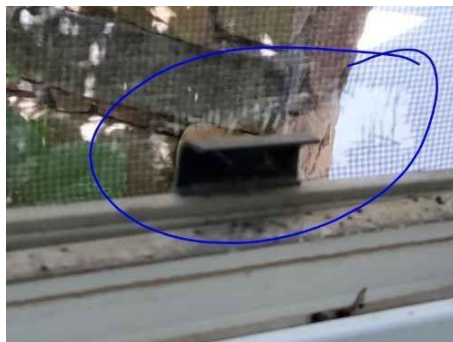
The center window is missing the screen and the frame is falling apart.

Recommend repair / replacement by the homeowner or qualified window contractor.

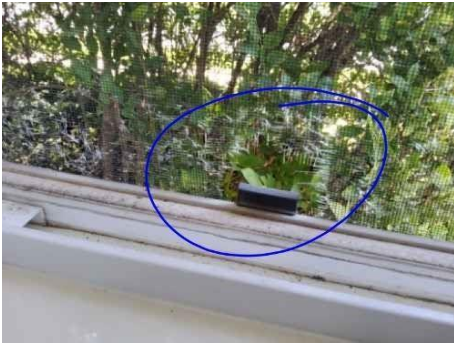
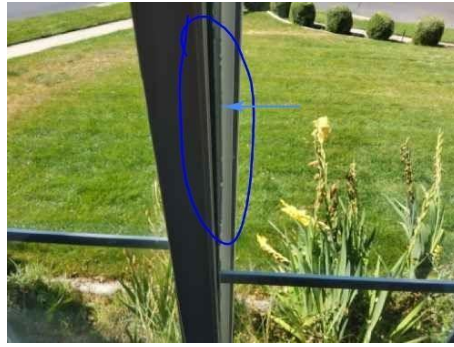
**WINDOWS** Fair

The side window screens are falling apart.

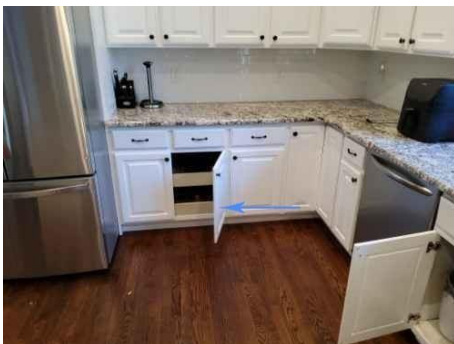
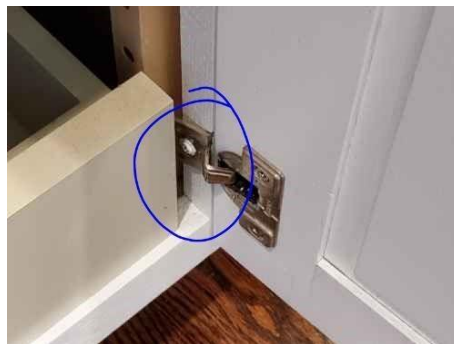
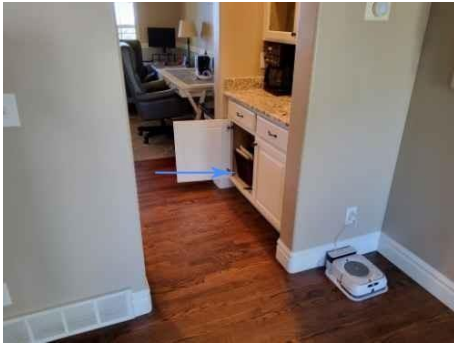
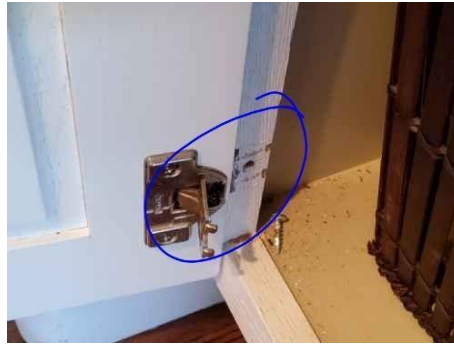
**CABINETS** Fair  
 Notes:

The bottom hinge is loose on the cabinet door to the right of the refrigerator.

The bottom hinge is damaged in the bottom cabinet of the room between the kitchen and the den.

Recommend repair/replacement by a homeowner or handyman.

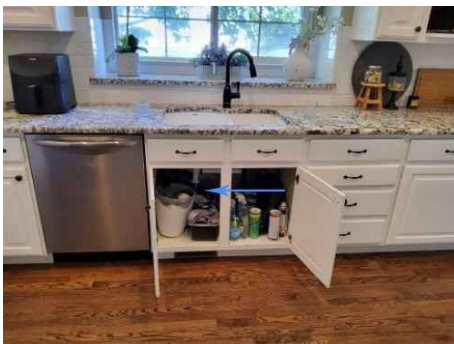
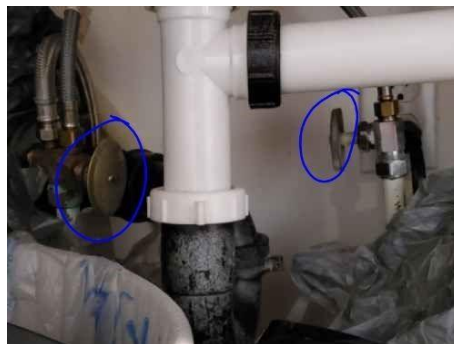
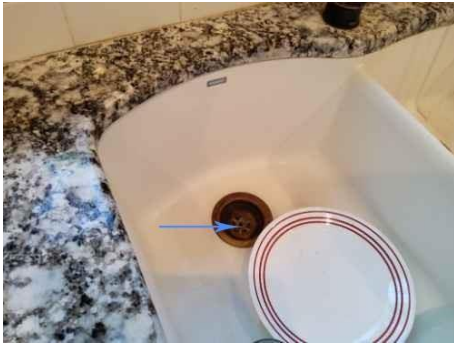
## SINK / GARBAGE DISPOSAL Fair

I am unable to turn the shut-off valve on the supply lines.  
They should turn very easily. I do not attempt to force them because they may break.  
The left sink drains slowly.  
Recommend further evaluation from a qualified plumber or handyman.

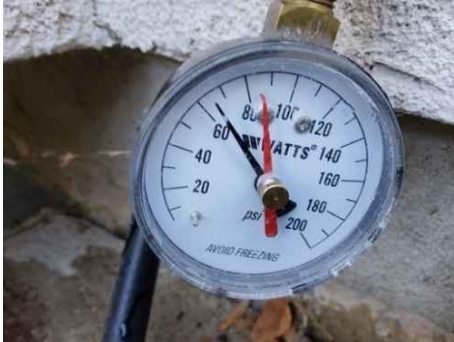
The water pressure should be between 30 and 80 psi. The water pressure is about 65 psi.

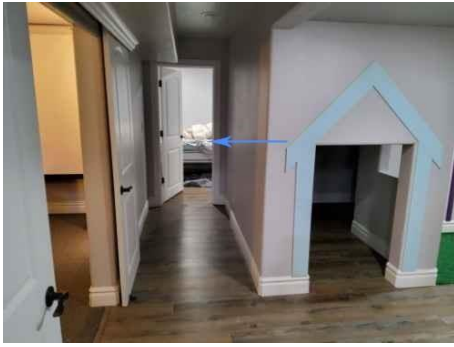
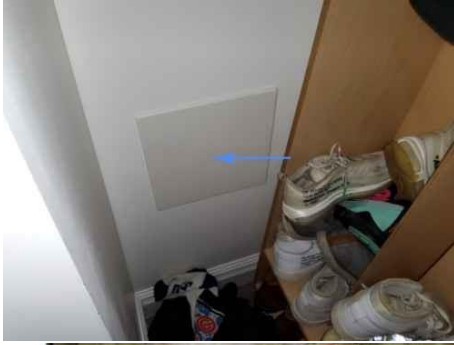
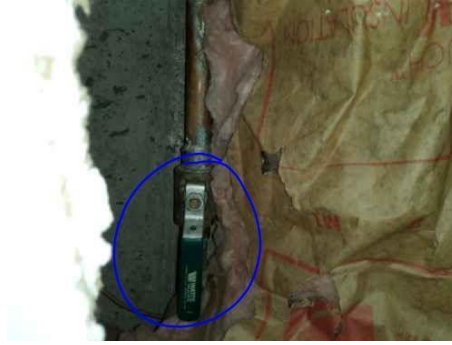
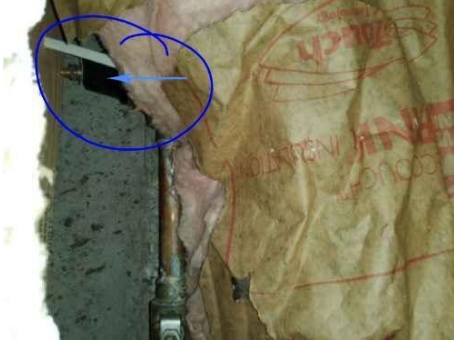
The main shutoff valve for the water is located in the east basement bedroom closet. The water pressure regulator/adjustment valve is directly above it.

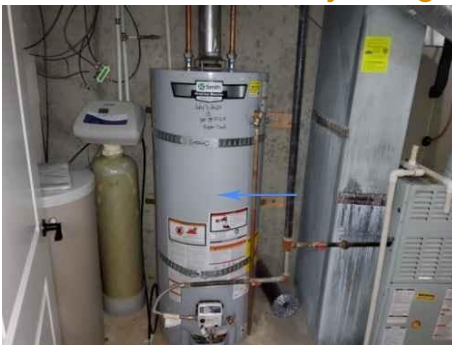
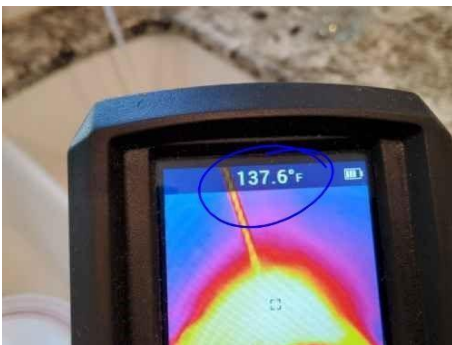
The typical maximum temperature of water from a water heater should be around 120 degrees. The water temperature is about 137.6 degrees.

Recommend adjusting the water temperature to 120 degrees or below.

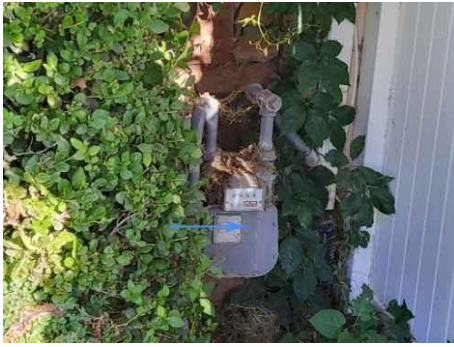
The gas meter is located outside on the east side of the house.

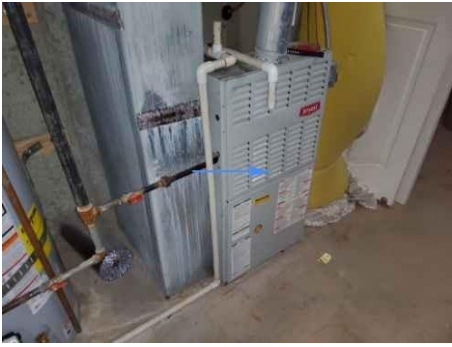
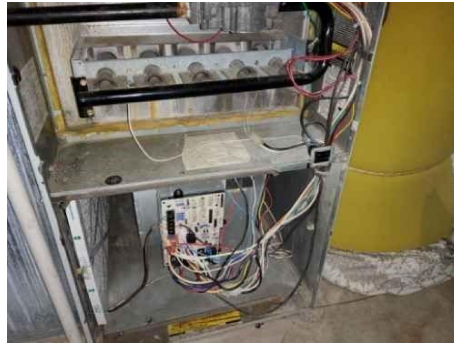
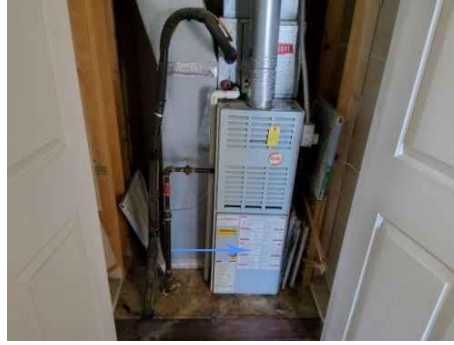
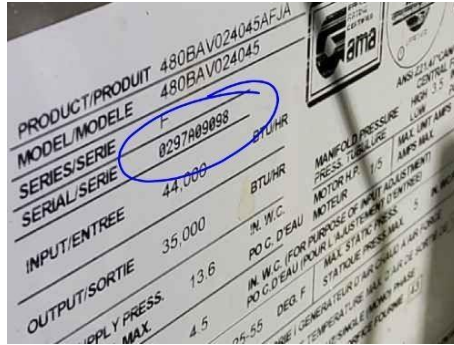
The furnace equipment is near the end of its service life.

Recommend annual maintenance and cleaning of the furnace.

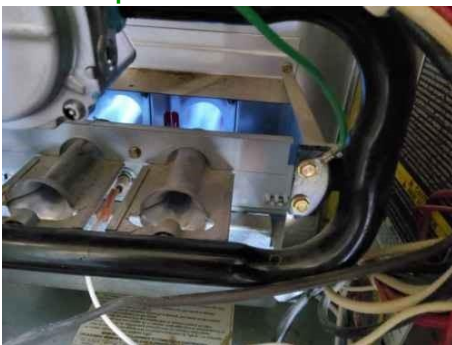
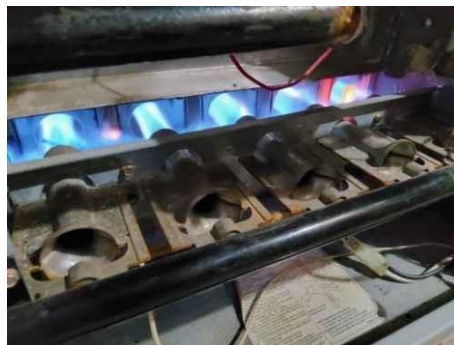
Both heating systems were functioning properly at the time of the inspection.

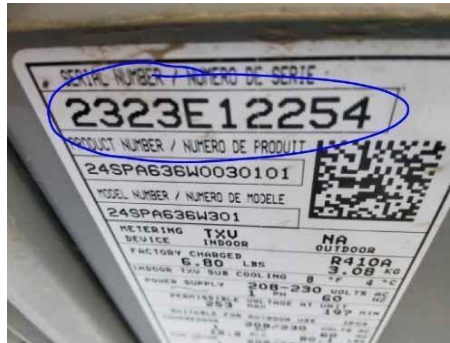
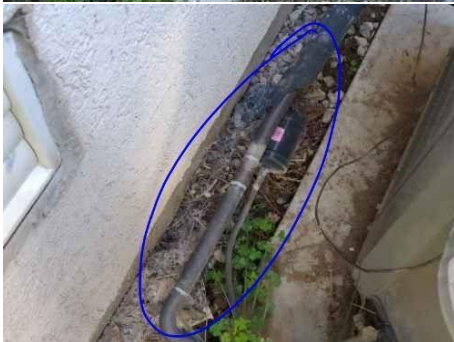
The north air conditioner is about 2 years of age.

The insulation on the north air conditioning unit tubing is falling apart.

The south air conditioner is about 27 years of age.

The south air conditioning equipment is near the end of its service life.

Recommend further evaluation/repairs by a qualified HVAC contractor or handyman.

Recommend keeping weeds and debris away from the condenser unit.

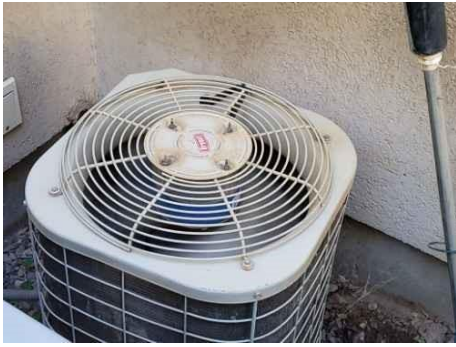
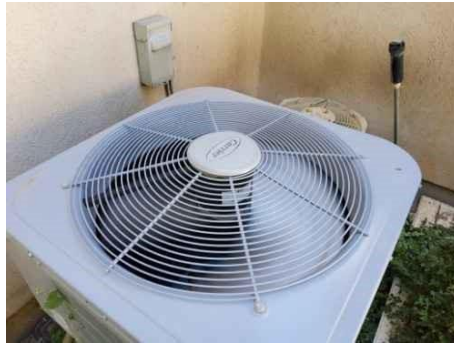
There are two air conditioning units.

The air conditioning units were functioning properly at the time of the inspection.

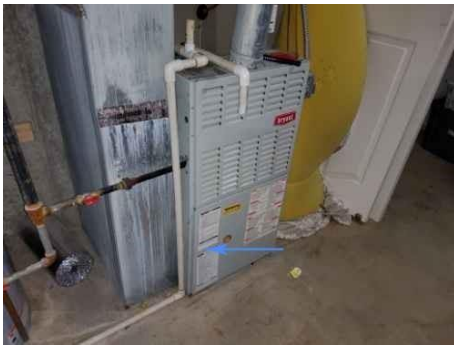
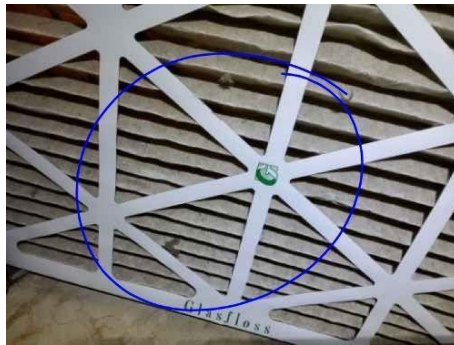
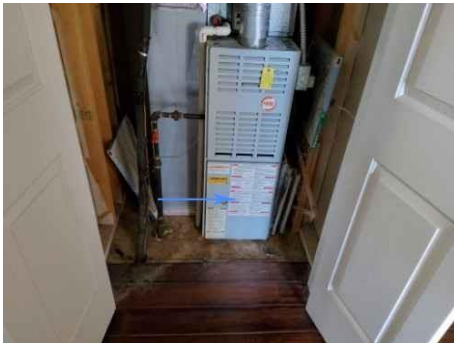
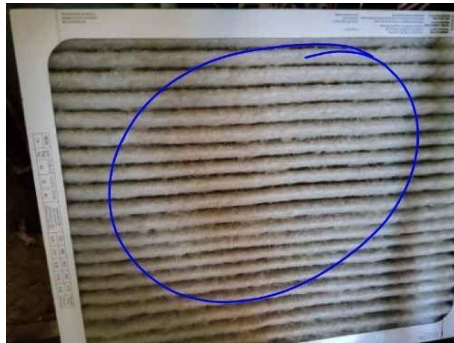
Both air filters need to be replaced.

Filthy air filters can lead to clogged evaporator coils, poor air flow and premature failure of the furnace and air conditioning equipment. When installing an air filter, ensure the arrow on the filter is facing the furnace.

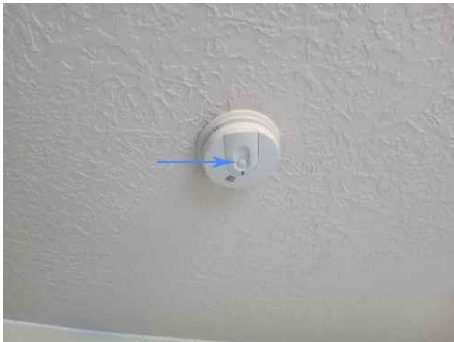
## SMOKE ALARM(S) Fair

The average lifespan of a smoke alarm is about 10 years.

Recommend replacing the smoke alarm(s)

Only a couple smoke alarms were inspected. Recommend checking all the smoke alarms in the house and replacing if necessary.

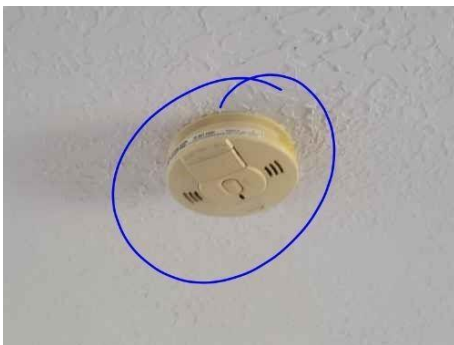
The inspection does not warrant that the smoke alarms are functioning properly. It only indicates that a smoke alarm was present. The test button does not test the workability of the device. It only tests the alarm.

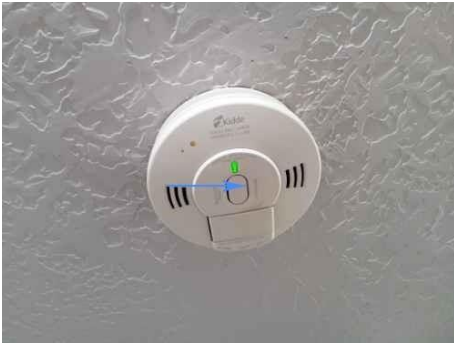
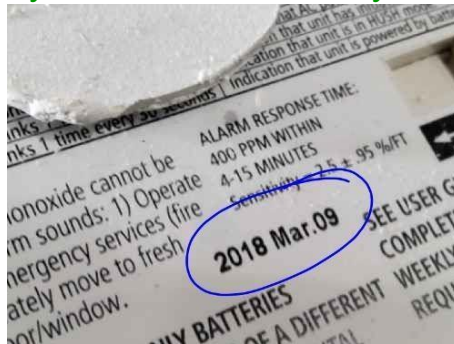
## **CARBON MONOXIDE ALARM(S)** Satisfactory

The average lifespan of a carbon monoxide alarm(s) is 10 years. The carbon monoxide alarm(s) are about 7 years of age.

Only one carbon monoxide alarm was inspected. Recommend testing all alarms and replacing if necessary.

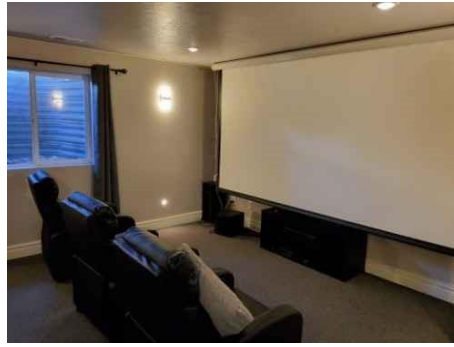
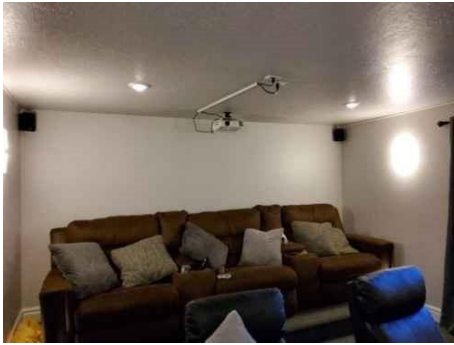
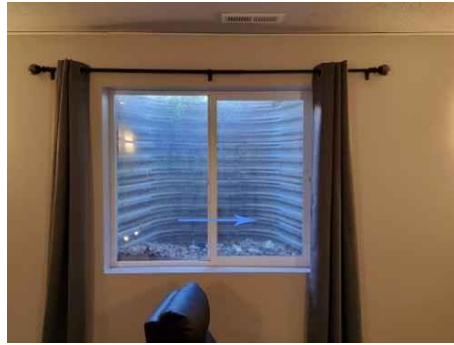
The window is missing the screen. Recommend repair / replacement by the homeowner or qualified window contractor.

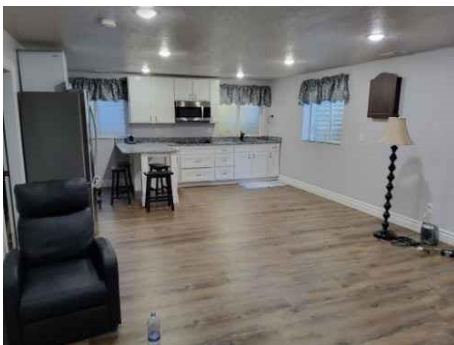
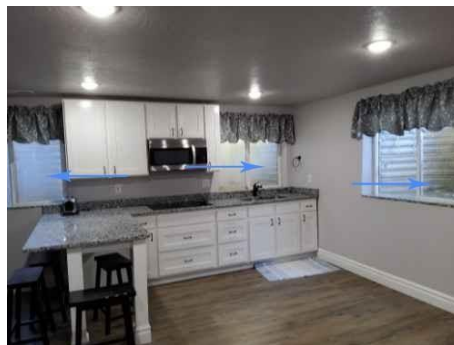
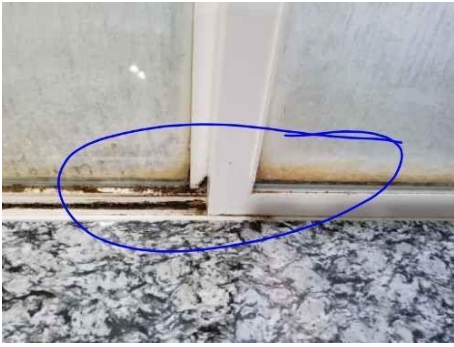
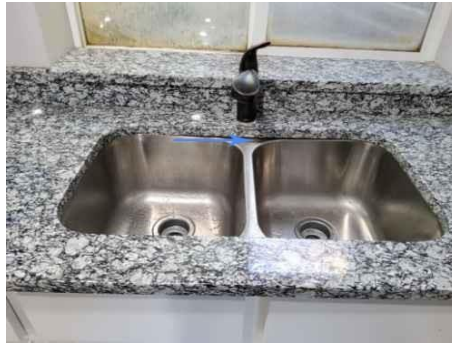
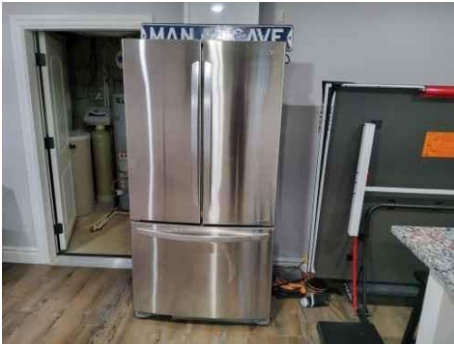
## BASEMENT KITCHEN Fair

The windows are missing the screen.

The windows and window frames have heavy water stains on the bottom of them. Continue to monitor to make sure any water in the window well does not get as high as the windows.

Clean out the window wells so water cannot collect in them.

Recommend adding sealant between the sink and the countertop to keep water from going behind it and into the wall and cabinet base.

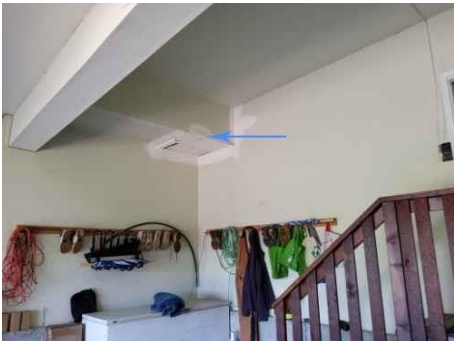
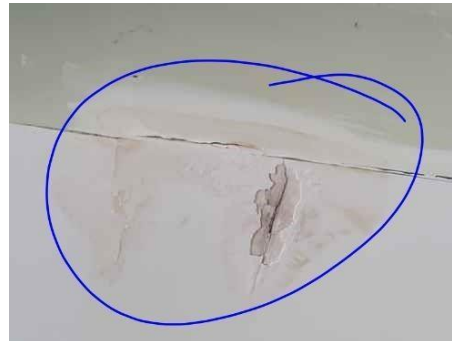
There are water stains and water damage on the ceiling of the garage. It was not wet at the time of the inspection. Recommend asking the current owner the cause of the water damage.

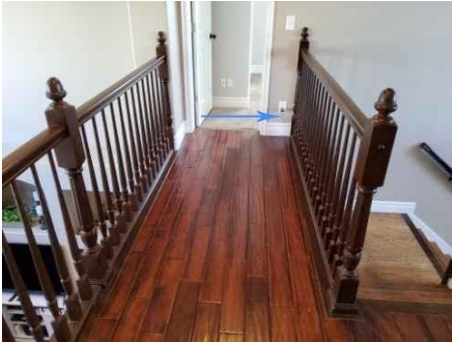
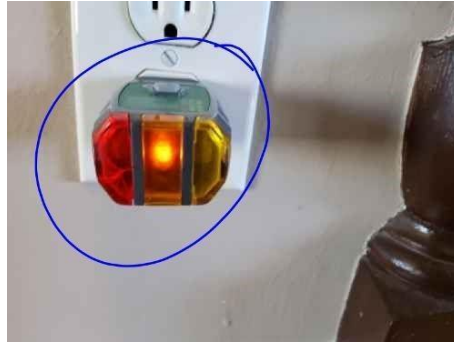
The outlet by the east bedroom indicates an open ground.  
Recommend further evaluation from a qualified electrician.

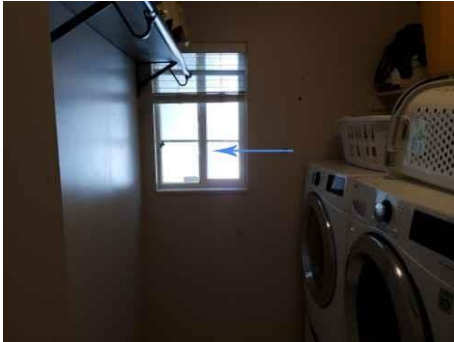
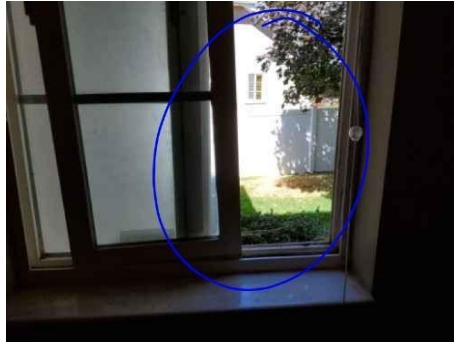
The window is missing the screen. Recommend repair / replacement by the homeowner or qualified window contractor.

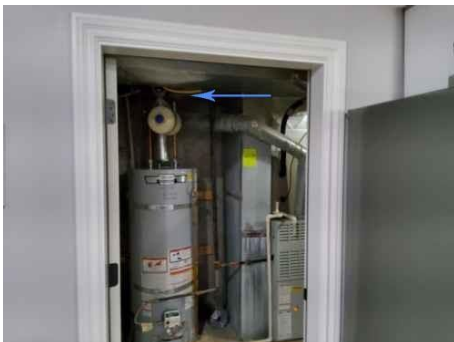
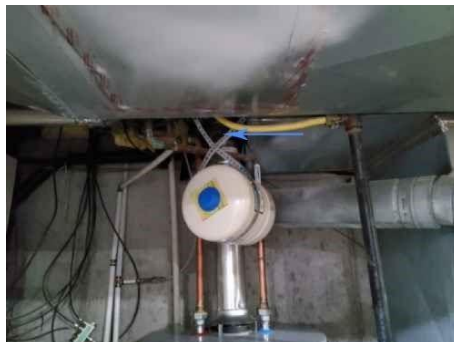
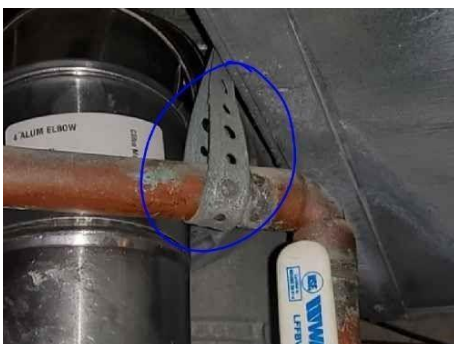
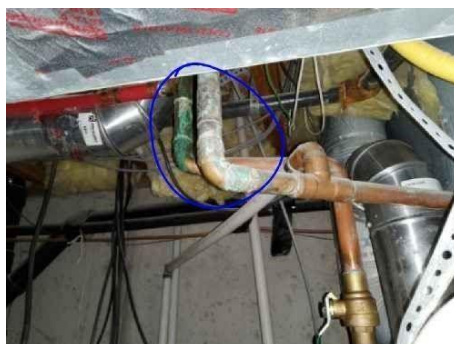
**FURNACE ROOM      Poor**

Copper piping should not touch galvanized materials. This causes what is called galvanic corrosion and will damage the copper pipe.

Some of the copper pipe coming off the water heater has corrosion on it. Recommend repair from a qualified plumbing contractor.

Some electrical boxes are missing the cover plate. Recommend repair / replacement by a homeowner or handyman.

Copper piping should not touch galvanized materials. This causes what is called galvanic corrosion and will damage the copper pipe.

Some of the copper pipe coming off the water heater has corrosion on it. Recommend repair from a qualified plumbing contractor.

**Some electrical boxes are missing the cover plate.**

**Recommend repair / replacement by a homeowner or handyman.**

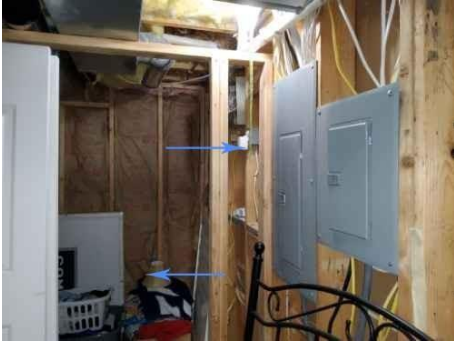
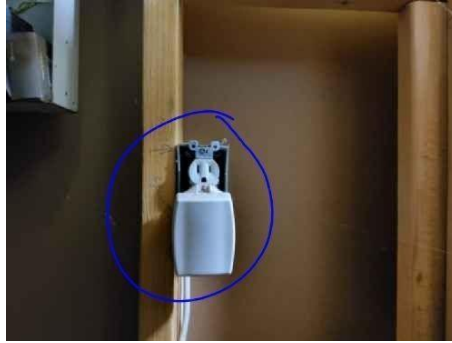
The electrical box is missing the cover plate.

Recommend repair / replacement by a homeowner or handyman.

**The electrical box is missing the cover plate.**

**Recommend repair / replacement by a homeowner or handyman.**
